WETLAND DELINEATION REPORT

**Gateway Business Park
City of Beloit, Rock County, WI**

**October 12, 2012
Delineation #17.2012**

Wetland Delineation Report

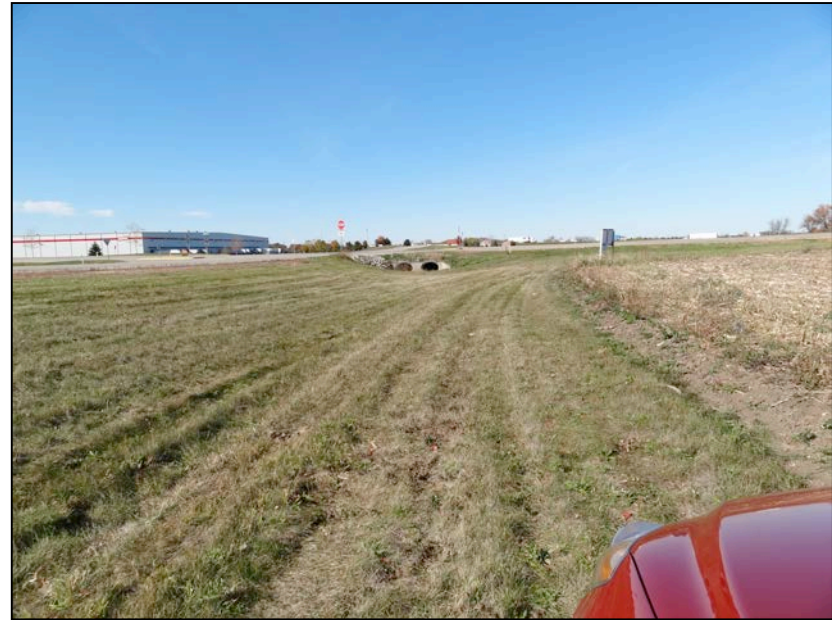
View of roadside ditch near data point #4, facing west. Northeast corner of Colley Rd and Gateway Blvd in background

- I spoke on the phone with Stacey Marshall, US Army Corps of Engineers and she suggested I flag it in case she determined the Corps had jurisdiction over it. The wetland flags extend within the maintained ditch from the large culvert to the point where reed canary grass is replaced by common brome grass. The WI DNR has a wetland exemption for maintained roadside ditches.

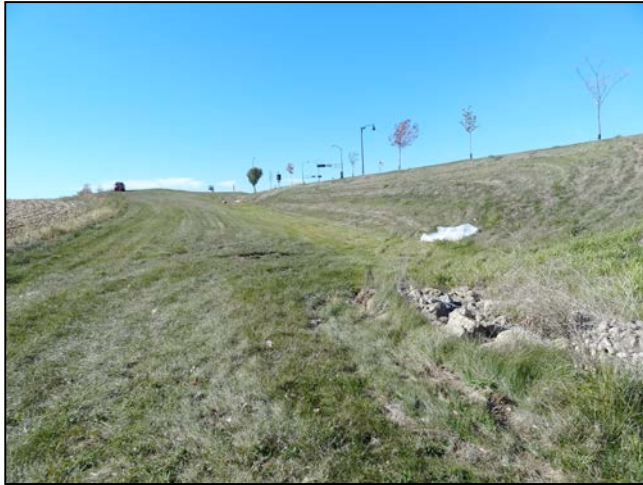
Riprap below small culvert – right side of photo

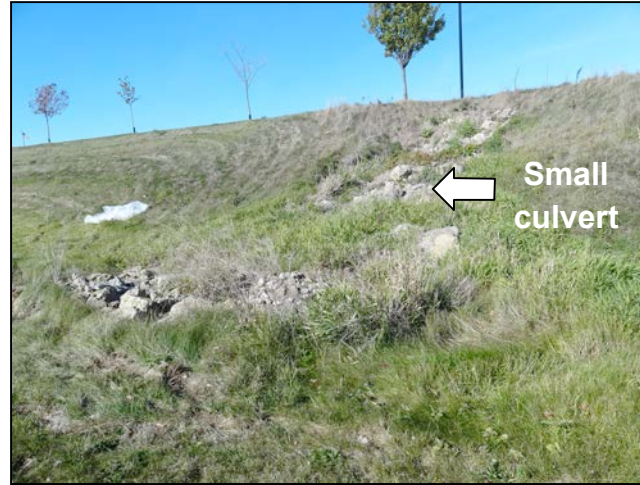
View of small culvert that drains Gateway Blvd

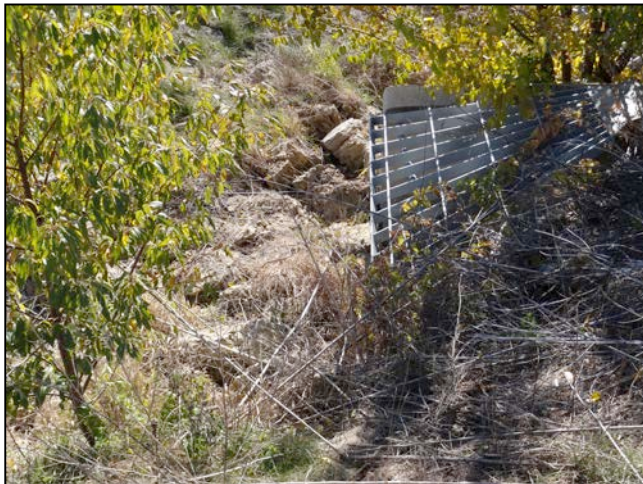
Large culvert that flows under Gateway Blvd. Note the grate at the culvert's mouth.

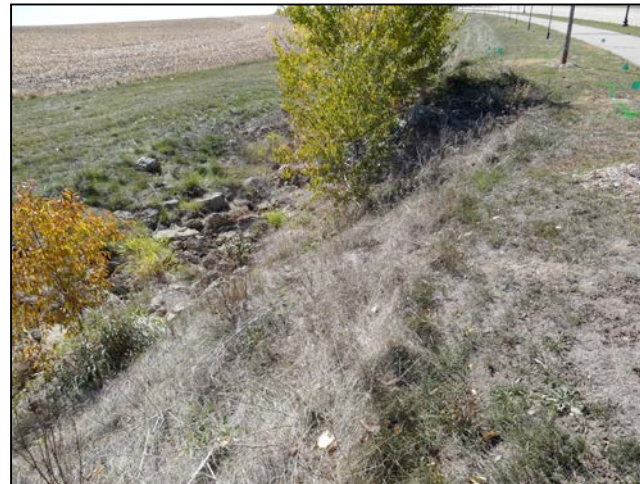
View of large culvert from roadside

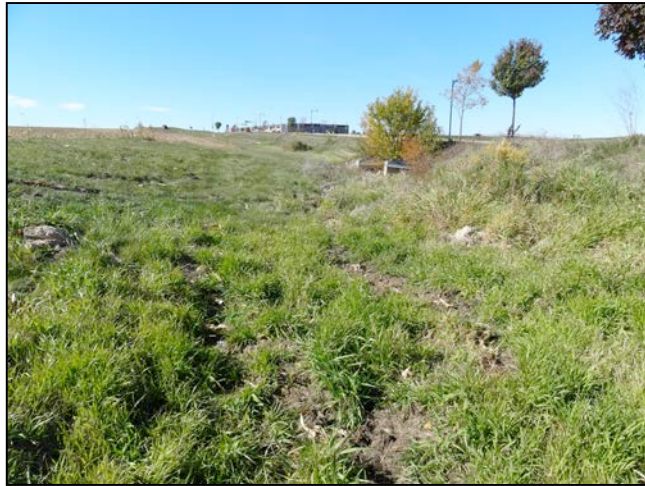
Wetland drainage way – wetland flags not yet added

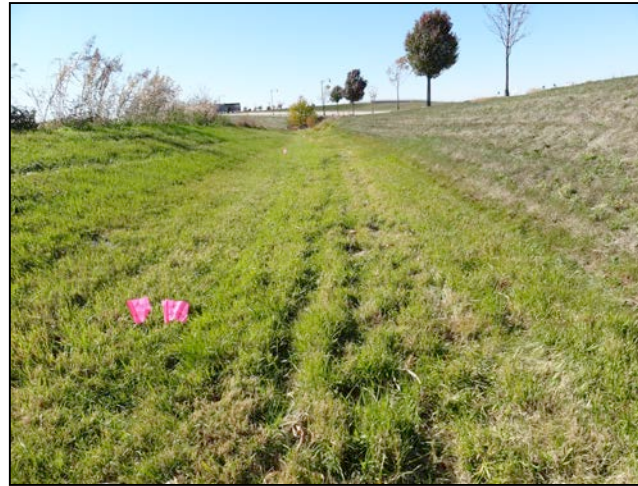
Wetland drainage swale with delineation flags

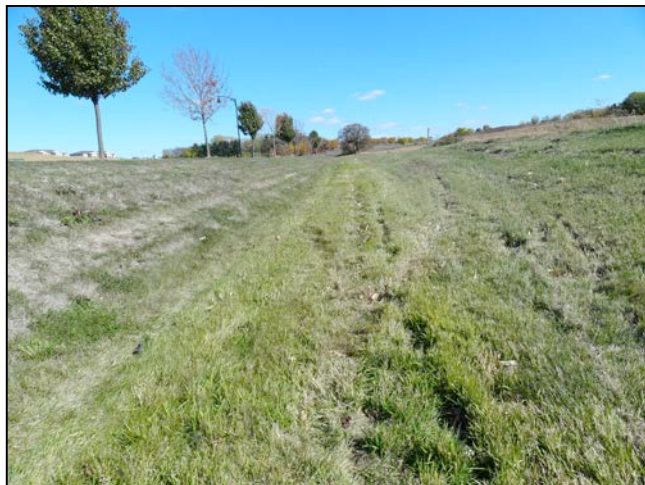
Facing north – ditch loses wetland vegetation

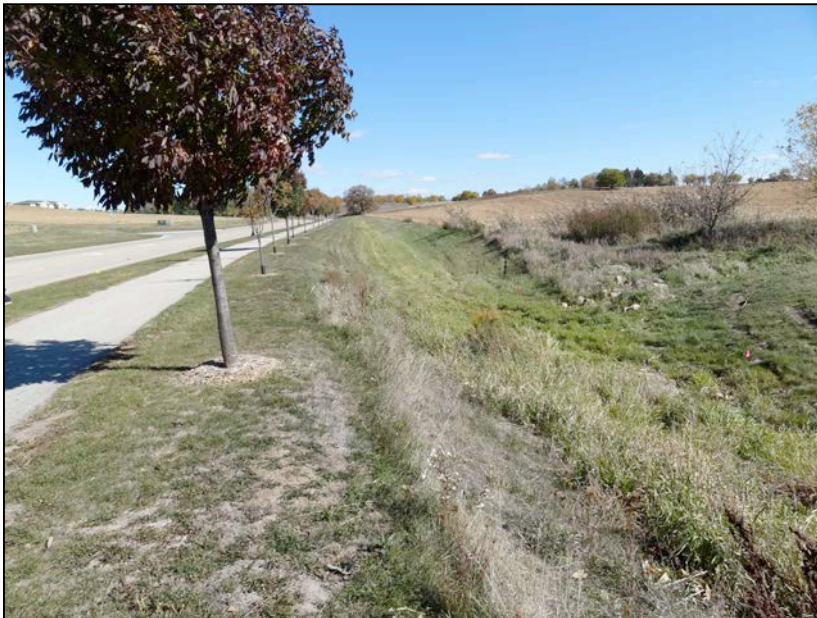
Looking east along Gateway Blvd. Wetland drainage swale visible on right with pink delineation flags. Drainage way loses wetland characteristics toward back of photo.

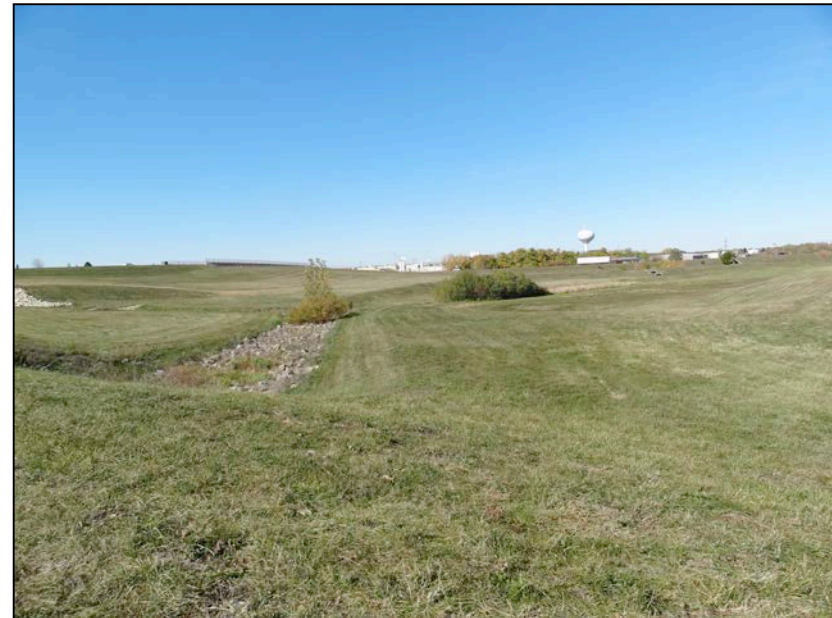
Water flows off the site to the drainage way above, northwest of the intersection between Gateway Blvd. and Cranston Rd. I-39 in far background.

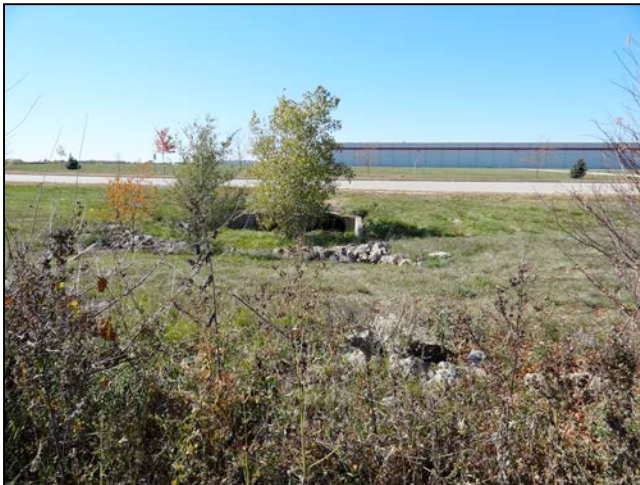
View of culverts under Gateway Blvd near data points 11 and 12, facing west

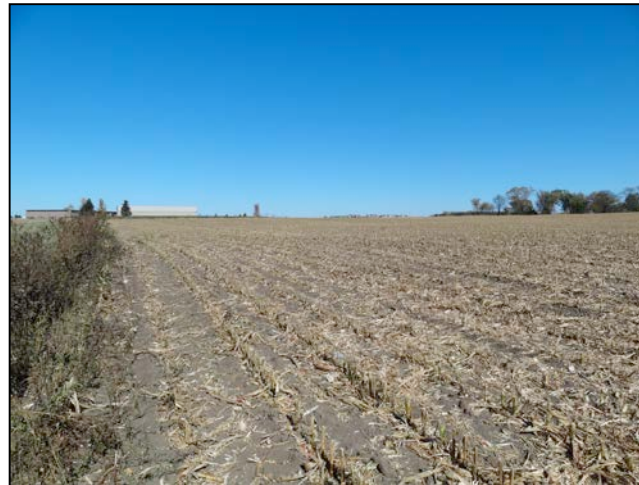
- The final area of possible wetland conditions is the area of Prior Converted farmland on the west side in the vicinity of data points 11 and 12. There were upland soils, uniform corn stalks and no indication of wetland conditions (photo page 6).
- With the exception of the roadside ditch area staked on the northwest side of the site the entire project area of 155 acres is **Upland**. The soils are brown 10YR 3/2 or 10YR 4/3 silt loams throughout. Although I was not able to view the FSA crop history slides as they are currently unavailable, the unequivocal upland soils, high landscape positions and uniform corn stubble did not indicate any concern that wetlands could revert in these areas once agriculture ceased.

Prior-converted wetland area in western part of site near data points 11 and 12

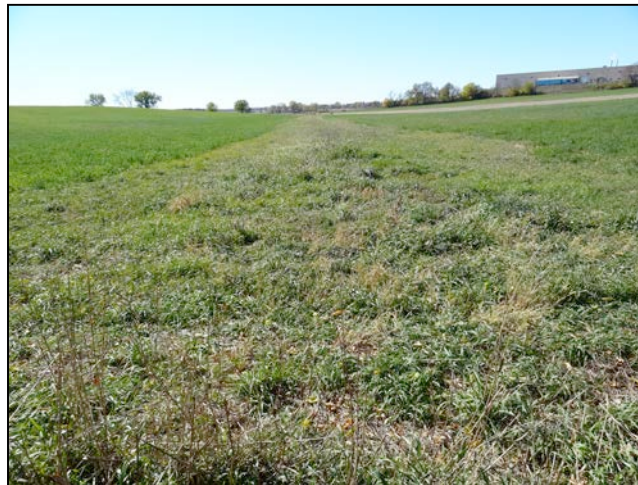
View at data point #9, looking south at grass drainage way through alfalfa field with brome grass
