Reference: Wetland Determination, Parcel 0413300001, City of Janesville, Rock County, WI Stantec Project #: 193702105

Stantec Consulting Services, Inc. (Stantec) completed a wetland determination on Parcel 0413300001 (the "Property") on behalf of the City of Janesville. The Property is located in Section 13, Township 2 North, Range 12 East, City of Janesville, Rock County, WI. The Property lies southwest of the intersection of STH 11 and Beloit Ave and is comprised of approximately 225 Acres. A field wetland determination was completed by Jeff Kraemer, Stantec on October 4, 2012. No wetlands were identified on the Property.

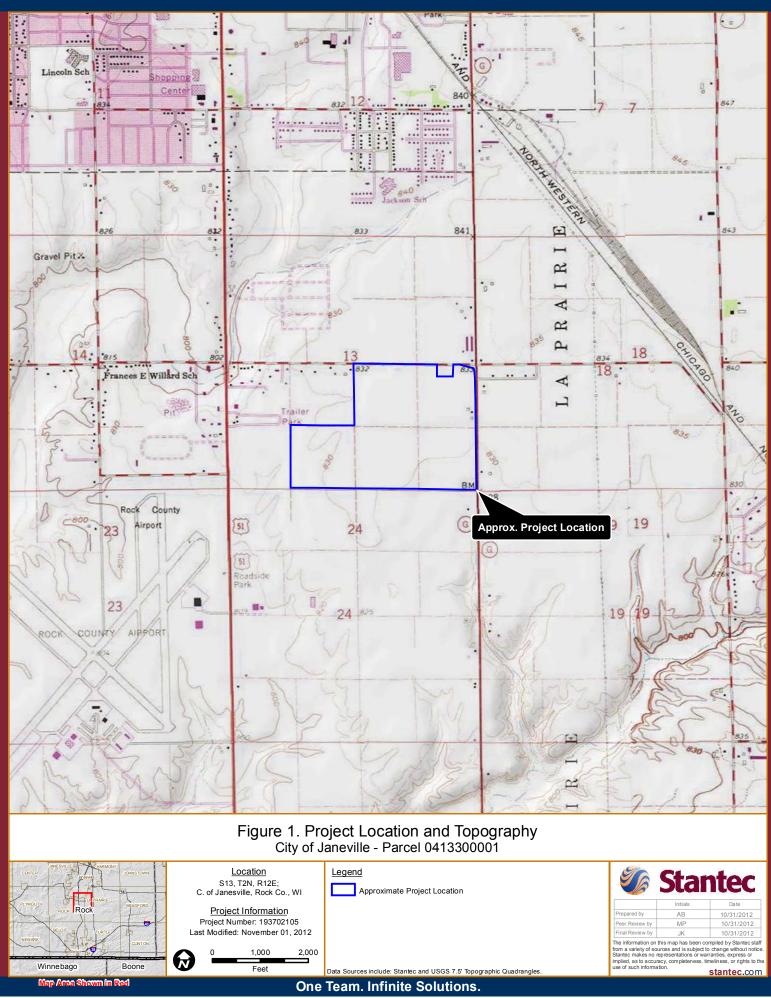
- United States Geological Survey(USGS) Topographic Map (Figure 1)
- 2. Natural Resources Conservation Service (NRCS) Soil Survey excerpts (Figure 2)
- 3. Wetland Inventory maps including the Wisconsin Wetland Inventory (WWI) (Figure 3)

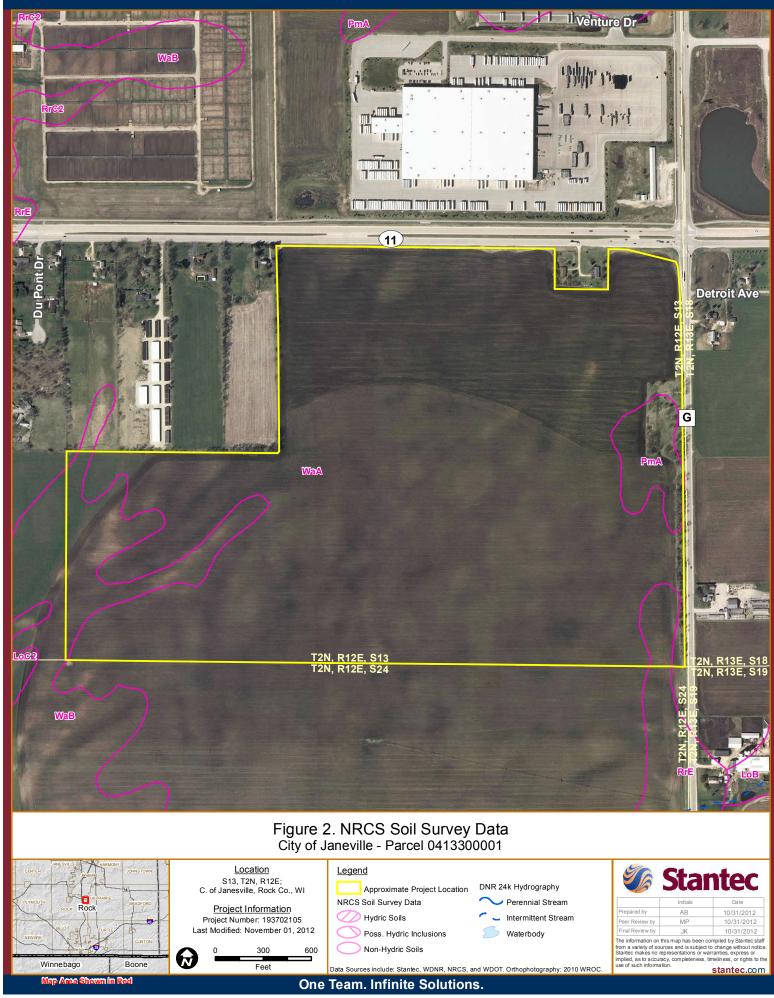
The Property is comprised of active agricultural fields with center pivot irrigation. Soils mapped on the Property by the NRCS Soil Survey of Rock County include Warsaw silt loam (WaA & WaB), Plano silt loam (PmA), and Rodman-Lorenzo complex (RrE) (Figure 2). No soil units mapped within the Property are hydric soils or known to contain hydric inclusions. The Wisconsin Wetland Inventory (WWI) map does not identify wetlands within the Property or within close proximity to the Property (Figure 3).

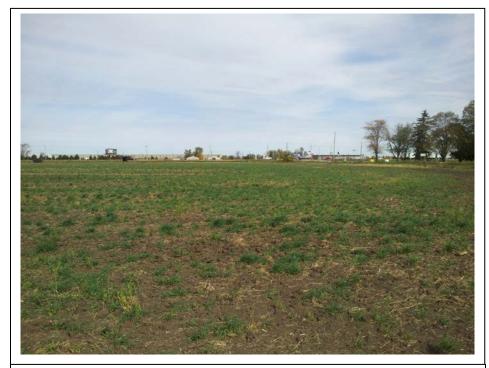
Photo 1. Upland hay field in northeastern portion of property viewing north at STH 11.

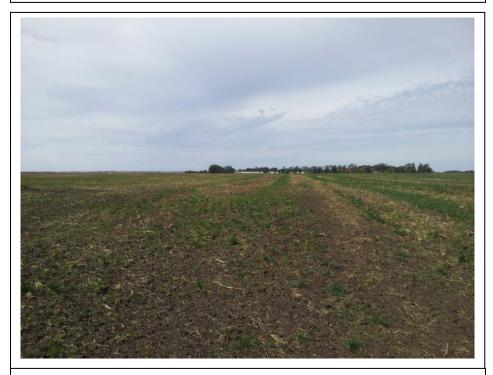
Photo 2. Upland hayfield viewing west from same location as Photo 1.

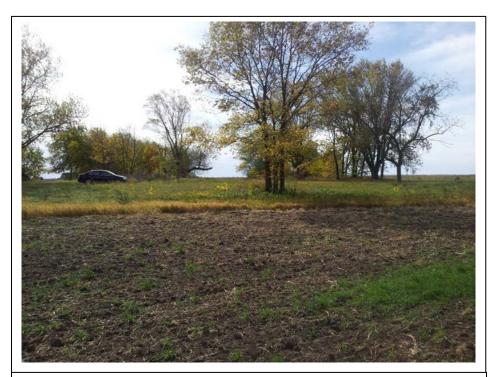
Photo 3. Upland unfarmed grassland/woodlot located in east-central portion of property along Beloit Ave. viewing southeast from the western side of area.

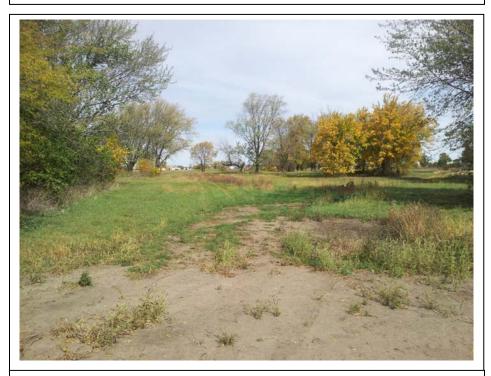
Photo 4. Upland unfarmed grassland/woodlot as in Photo 3 viewing south from northern portion of area.

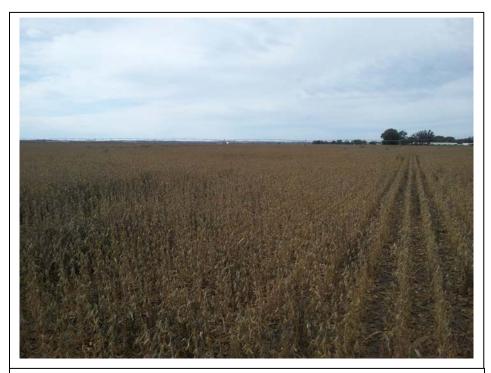
Photo 5. Upland soy bean field viewing southwest from central portion of property. Central pivot irrigation in foreground.

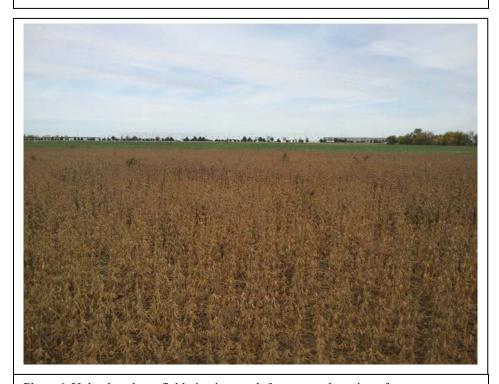
Photo 6. Upland soybean field viewing north from central portion of property.

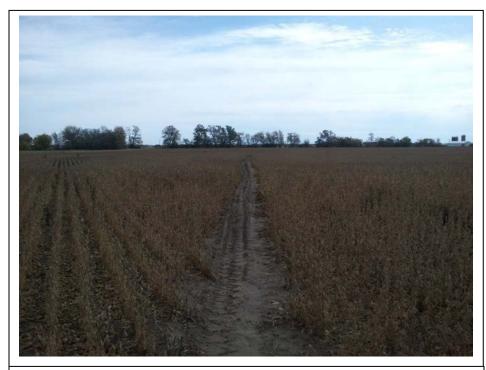
Photo 7. Upland soybean field viewing southeast from central portion of property. Irrigation wheel tracks in foreground.

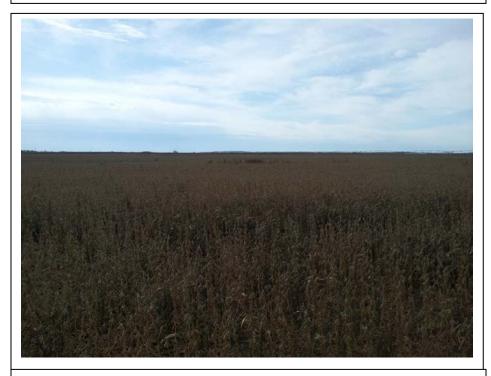
Photo 8. Upland soybean field viewing south from central portion of property.
